INSPECTION *report*

6677 Jane Street
Nampa, HI 83605

Wednesday, January 29, 2020

RE: Report No. 3295
6677 Jane Street
Nampa, HI
83605

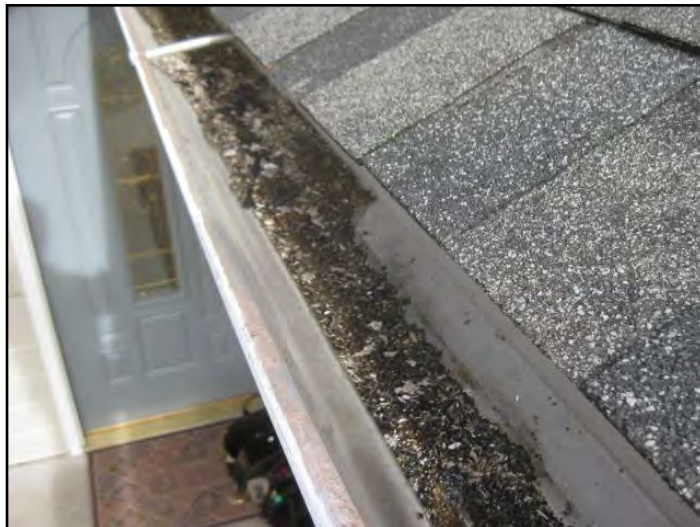
1. **Condition:** • Dirty/debris

11. *Dirty/debris*

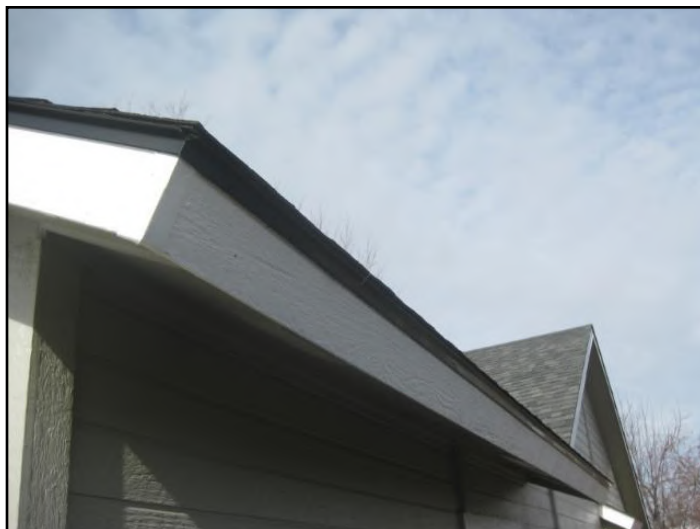
2. **Condition:** • Recommend gutters and downspouts around the entire home.

12. *Recommend gutters and downspouts around the...*

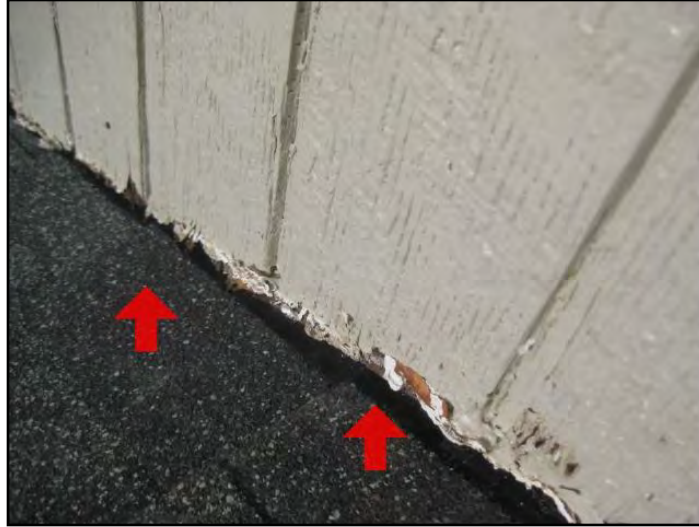
3. **Condition:** • Water damage

The siding above the front entry was cut to low to the roof which has resulted in some water damage. Recommend remove an 1-2 inches from the base of the siding at this isolated 10-12 foot section.

Implication(s): Chance of water damage to contents, finishes and/or structure | Rot

13. Water damage

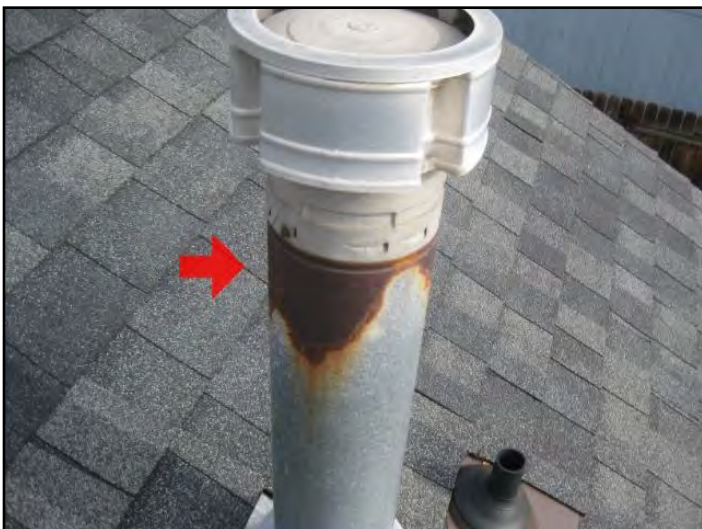
In addition, some rust was observed at the B vent on the roof. Although not unusual, its possible this acidic condensate from the combustion gasses that are not clearing the vent before condensing, then running down the edge coming out at the connection. Recommend during servicing a qualified HVAC technician assess the vent stack.

22. Rust at B vent

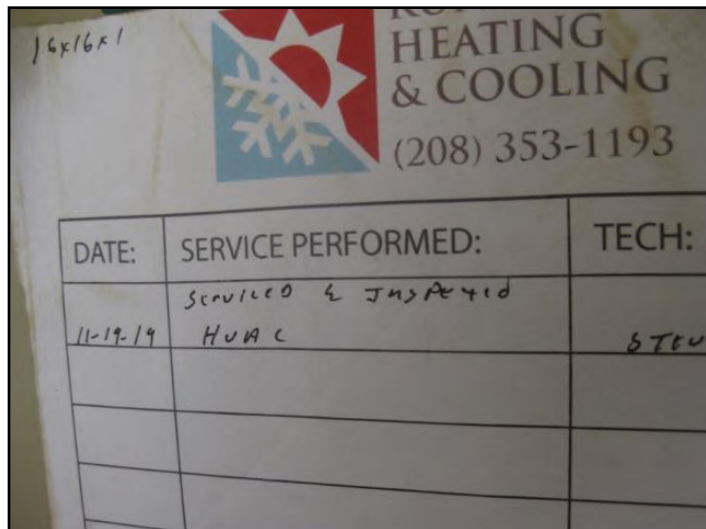
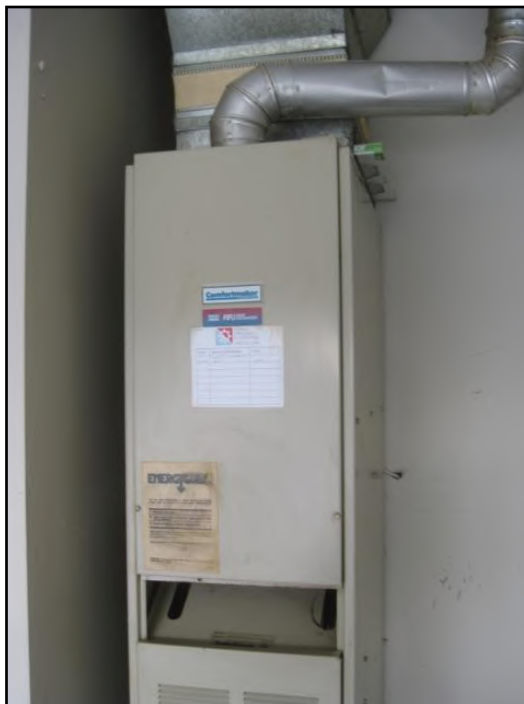
The furnace appeared to be an original to the build, however, the system did test and appear to be in adequate condition with at least one service that was recent. The unit appeared to be a conventional to mid efficiency system (recommend verify that with HVAC technician). The system did appear to properly function when tested with adequate heating in all rooms. Recommend a qualified HVAC technician further assess the system for basic maintenance to ensure all components are properly functioning and verify age of system and likely remaining viable years.

24. Service Furnace

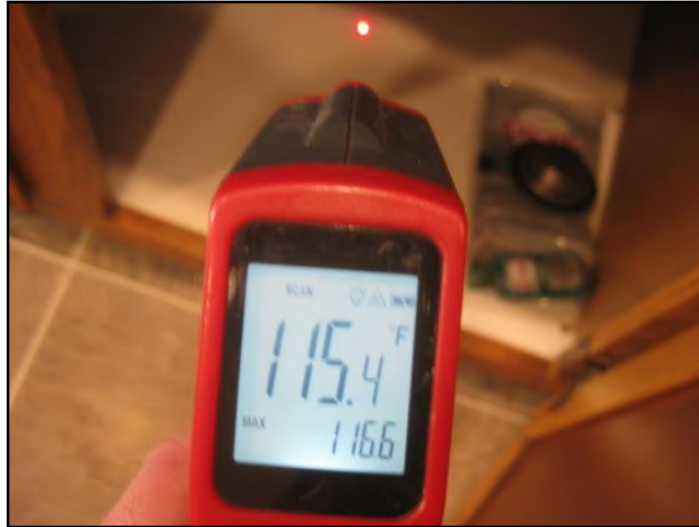
It appeared a heat vent was located either under the kitchen sink or a heating duct was broken/damaged under the kitchen sink cabinet. The base board cabinet of the sink was hot to the touch. Recommend a contractor or HVAC technician further assess the heating vent install under the kitchen sink.

25. Poor location

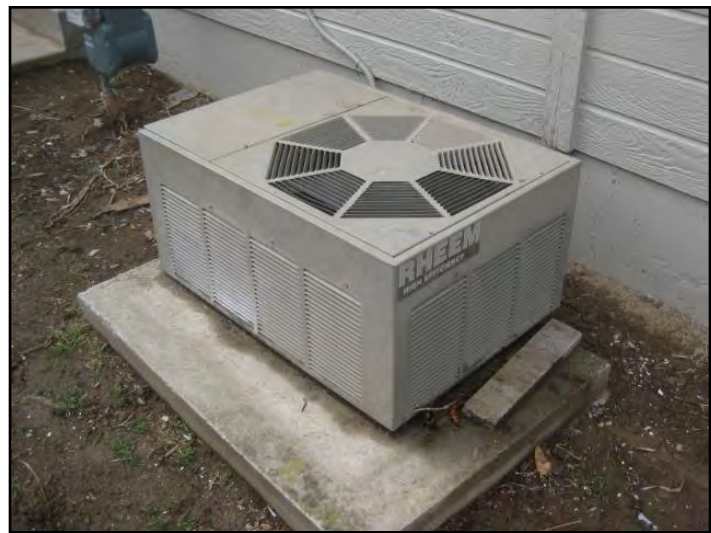
8. Condition: • Recommend servicing AC unit(s) annually.

27. Recommend servicing AC unit(s) annually.

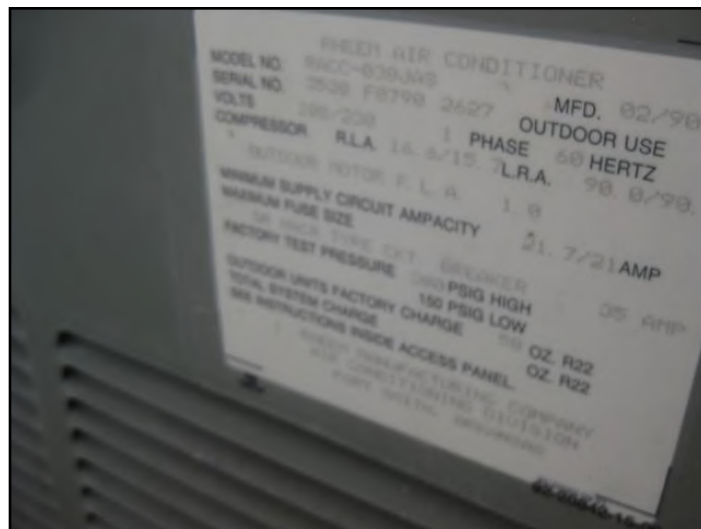
9. Condition: • R22 refrigerant, sometimes known as R22 Freon or HCFC-22 Freon, is an environmental danger because it contributes to the depletion of the ozone layer. The U.S. government has placed restrictions on R22 and has issued the requirement that R22 refrigerant must be eliminated from use in cooling systems by the year 2020. At this point, R22 will no longer be manufactured and cannot be used as a refrigerant in new air conditioning systems. R22 is being replaced by R-410A, a safer material which is the current, compliant standard refrigerant in air conditioning equipment.

The coolant data was not evident on the plate. Recommend during servicing a qualified HVAC technician determine if the coolant is R22.

28. R22 refrigerant

Complete air conditioning system replacement to an R422 model may be the most cost-effective solution.

Recommend a qualified HVAC technician further assess this system.

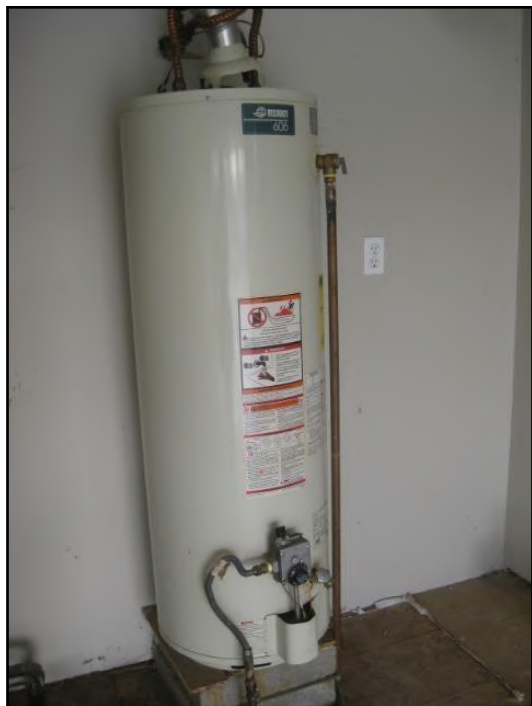
Although the water heater was tested and appeared to be functional, it is advisable to have the unit serviced to ensure proper operation and efficiency. Recommend moisture alarms be placed at the base of the tank and below all fixtures as a leak detection method. Recommend a timer be installed/utilized as a cost/energy saving measure. Recommend consult with the sellers as to any known history of service or maintenance on the system. A full INFRARED scan was conducted of the interior showing no readily observable water damaged areas. The temps at the fixtures were at or near 108. Ideal temps would be near 120-125 degrees. Recommend during servicing to increase temp if so desired.

32. Service water heater

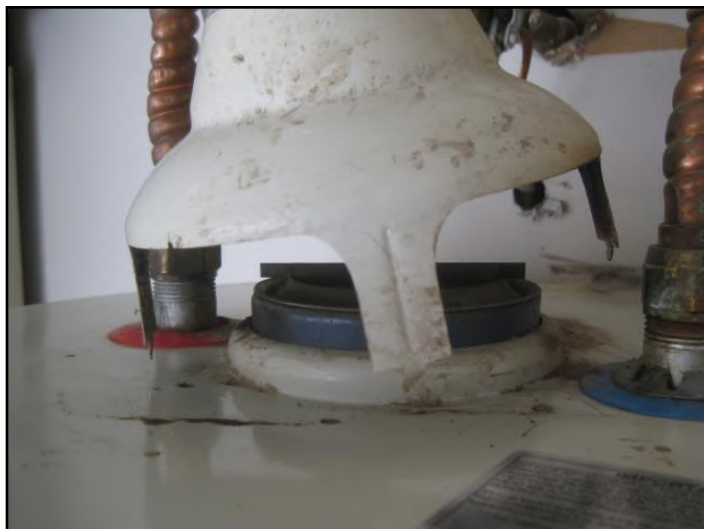
The vent stack at the top of the unit was loose. Recommend during servicing to have this properly secured to prevent accidental fume release into the living space.

33. Loose vent

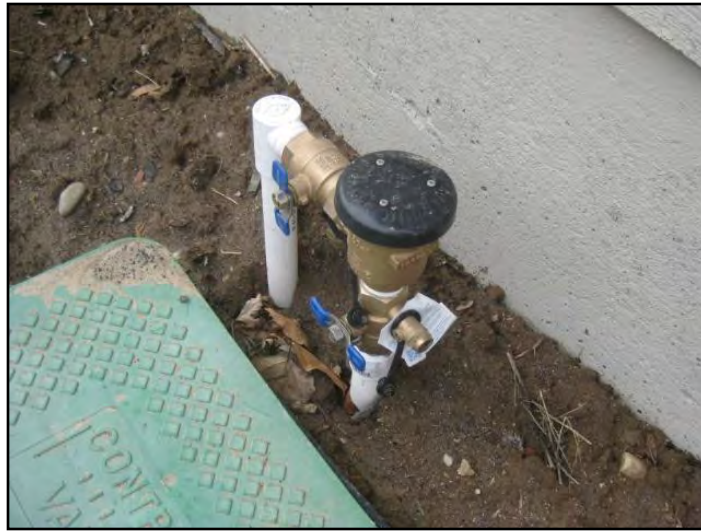
Although an irrigation system was observed on the property, it was not tested nor seen in operation. Recommend consult with the sellers as to its current status and history of maintenance or service. It did appear several sprinkler heads were damaged or in disrepair.

34. *Landscape irrigation system*

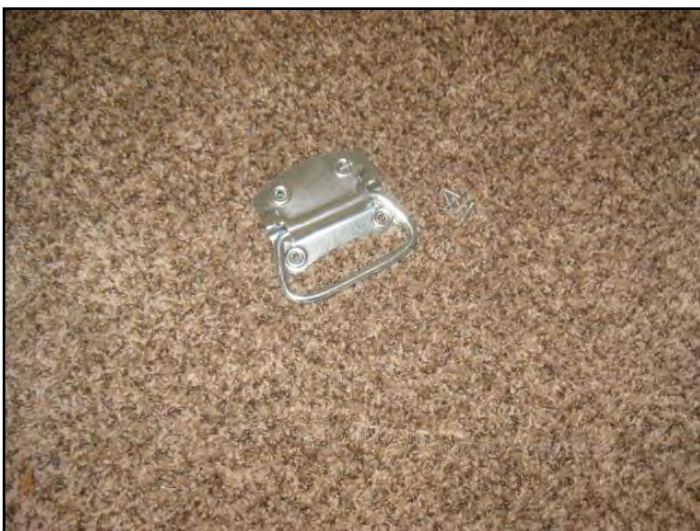
The crawl space hatch handle was loose and the hatch was a poor fit. Recommend properly securing the handle and trim/adjust the frame or hatch to easily allow access.

41. Loose handle

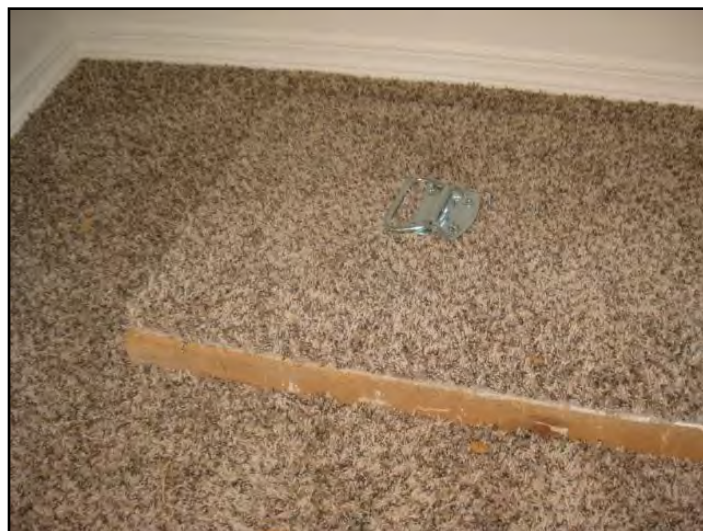
42. Poor fit

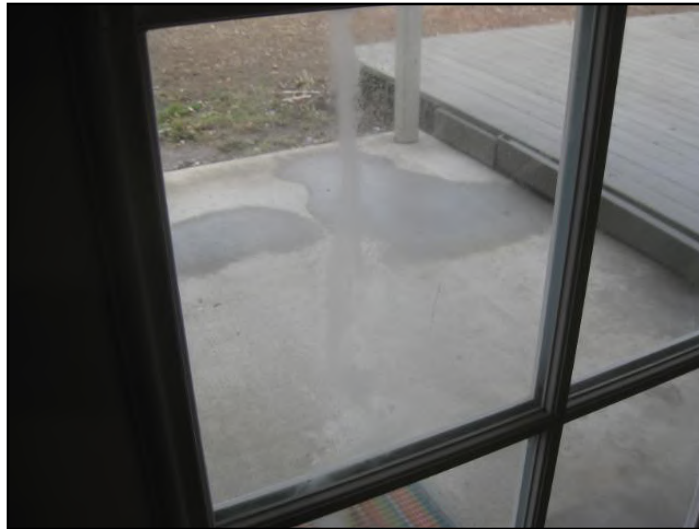
Several glass panes at the right side french door set had obscured glass or surface defects. Recommend further assessment for deep cleaning or possible replacement of the obscured glaze.

43. Surface damage

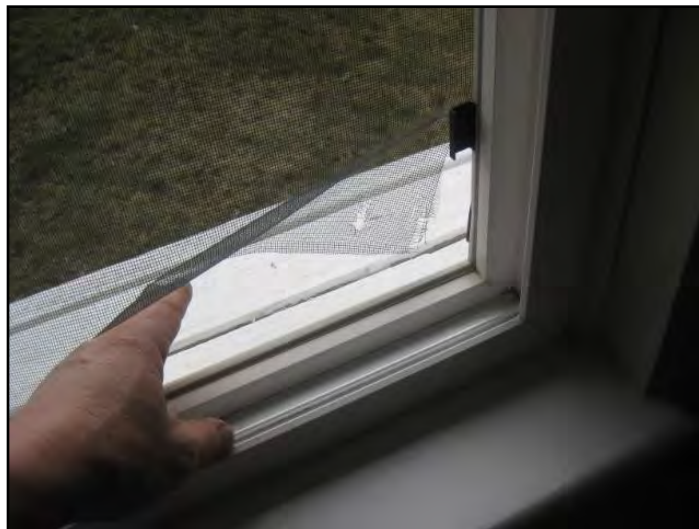
14. Condition: • [Torn](#)

44. Torn screen

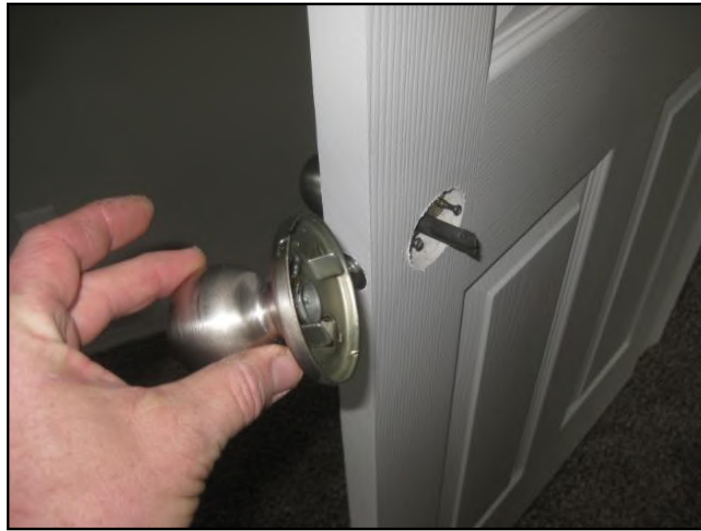
15. Condition: • [Loose](#)

45. Loose knob

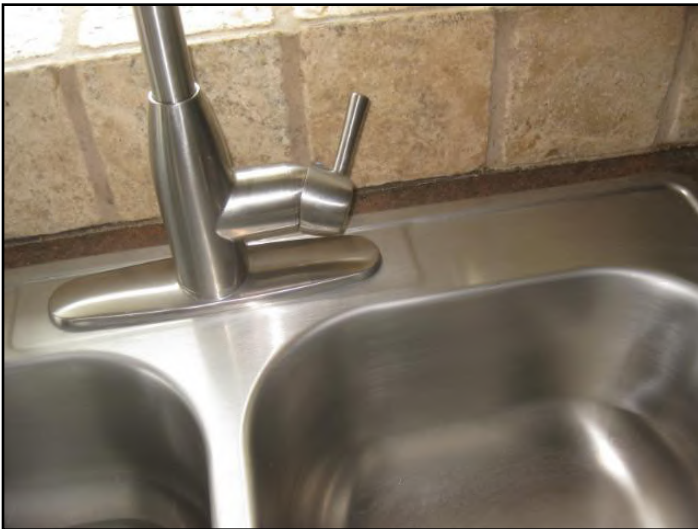
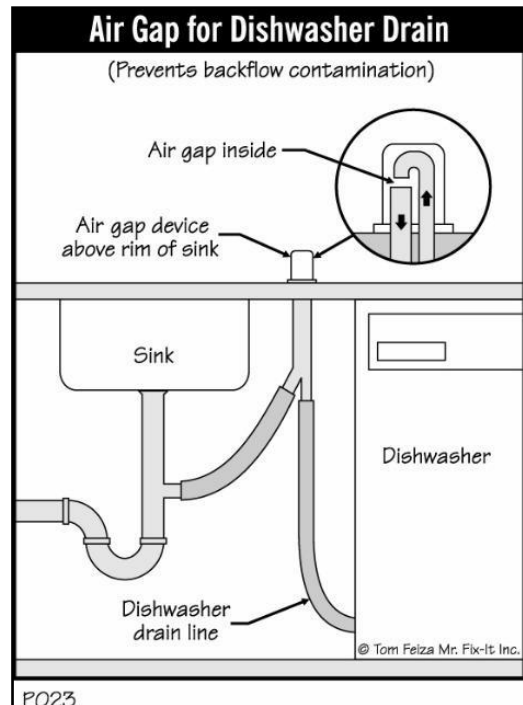
16. Condition: • Backflow prevention missing

46. Backflow prevention missing
